**Name of Vessel:**

**Hugh Ellacott**

**Yacht and Small Craft Surveyor**

## 1. About the Survey and this Report

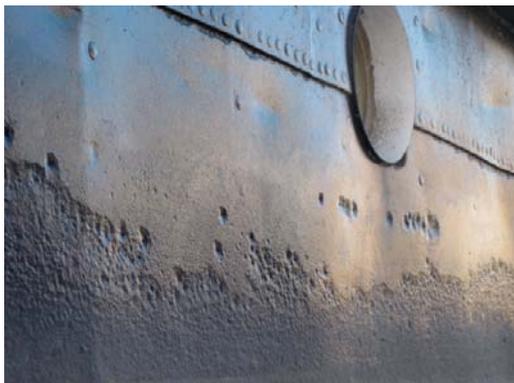
The topsides were painted in a dark navy gloss with a matt black boot top. A white undercoat underlay the navy topcoat. The coating was generally in good condition and there were few areas where it had failed. There was not time between the tides to examine the topsides in detail; extensive areas of pit corrosion were noted along the wind / waterline with isolated pits higher on the topsides. The coating has effectively halt corrosion to pitted areas of the topsides.

Pitting on topsides

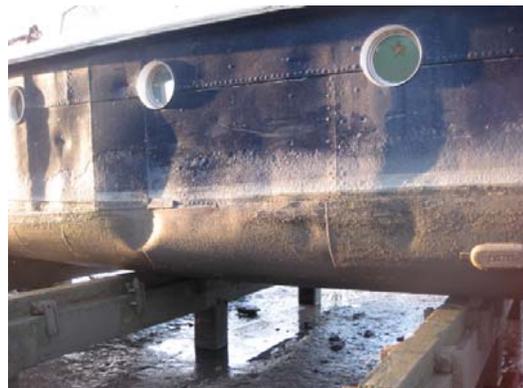
Impact dents to port amidships

A number of areas of impact damage were noted particularly on the port side amidships and at the stern. Three references thickness readings were taken from port bow topside plating as follows: 8.1mm, 6.7mm and 7.0mm.

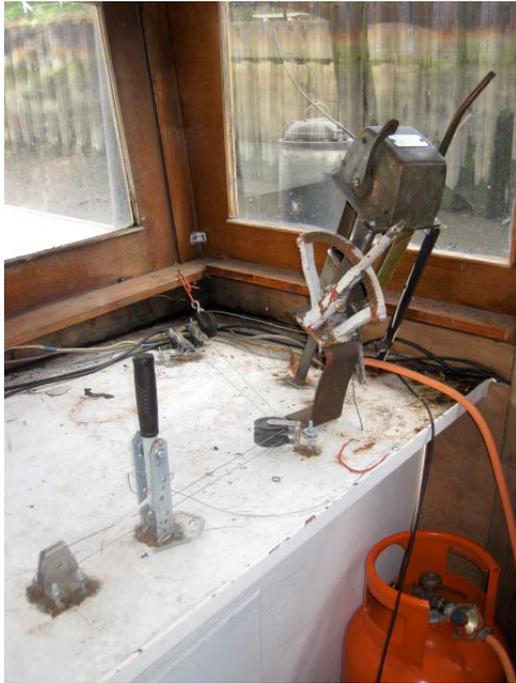
The mechanism for operating the steering is inadequate and should be condemned. It consists of a lever and pulleys mounted in the wheelhouse. The thin gauge wires feed back to the hydraulics via pulleys; in places it runs against steel potentially wearing the wire.

Steering and engine controls

I observed the steering in operation. The rudder operated effectively but hard to port represented only a 20° movement of the rudder, while to starboard the movement was approximately 40°. The rudder indicator in the wheelhouse was inverted and did not appear to be accurate.

*Recommendation*

*Replace steering mechanism, prior to use of vessel for navigation.*

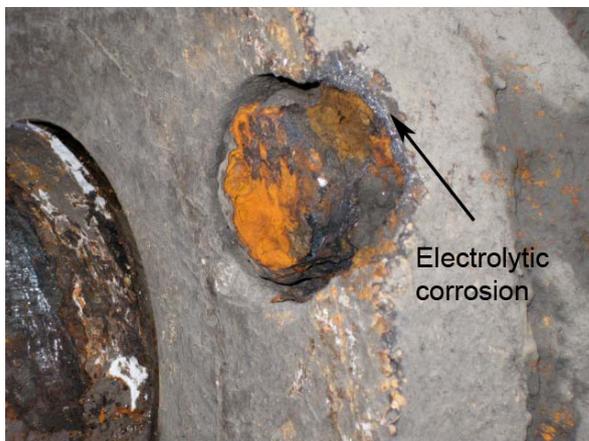
The prop shaft was magnetic and presumed to be mild steel; it turned freely. A large mild steel nut with tab secured the propeller to the shaft. It was hammer tested and found to be sound though it exhibited signs of corrosion in the form of rust scale. This corrosion does not present a threat to the security of the fastening given its massive size, but progression of corrosion should be monitored at each haul out.

The end cap for the stern tube was secured with mild steel bolts that were clearly corroding; however, they were hammer tested and found to be secure. There was evidence of minor electrolytic corrosion to the end cap adjacent to the recess for one of the securing bolts. However, the cap was hammer tested and found to be secure at the time of the survey. Progress of corrosion should be monitored at the next haul out.

*Draw shaft prior to use of vessel at sea (i.e. downstream of Thames Barrier) and inspect shaft by way of outboard bearing and propeller. Inspect end cap and replace if necessary.*

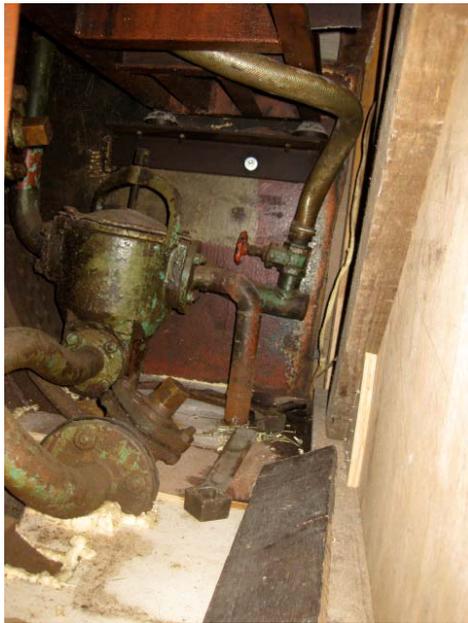
It appeared from the photograph and visual inspection from a distance that the higher of the two was closed by means of a gate valve. A length of 2" suction hose was attached to the valve and its open end was lodged up at deck level, indicating it was unused.

*Establish access to port side skin fittings, possibly by decommissioning and remove generating set and its engine. Inspect skin fittings once access has been established. This should be done as soon as is possible.*

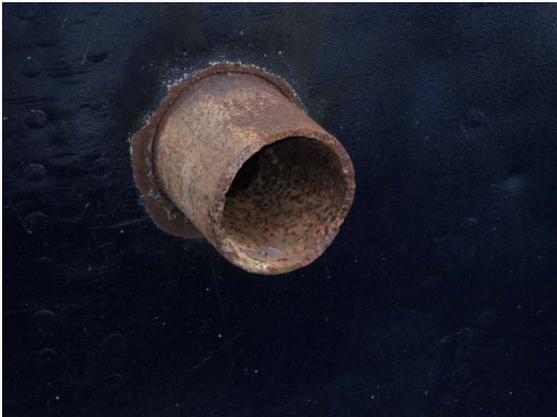
Access to the main saloon on the lower deck is via companionway steps from the foredeck. The steps are steel, are welded into the superstructure and are drained by means of a scupper that discharges to port. The pipework for the scupper is poorly finished.

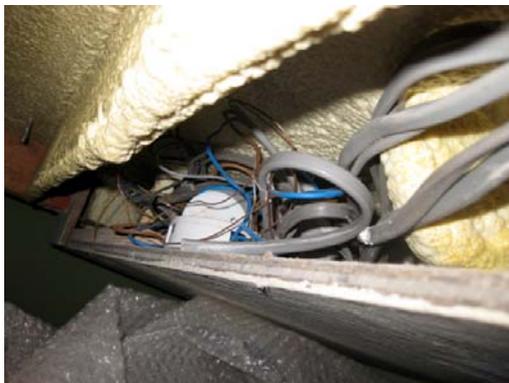
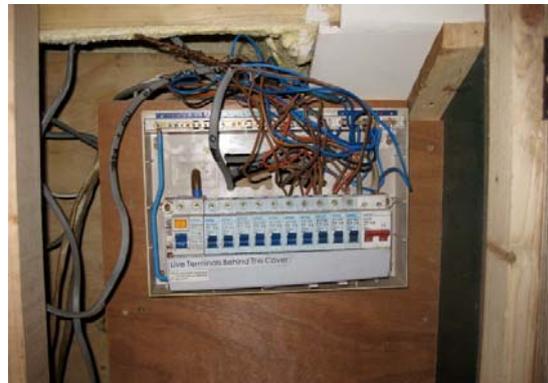
The 230/240 volt AC distribution box is located in a locker at the aft end of the lower deck passage. There was what I assumed to be a redundant distribution board adjacent to the generator in the engine compartment. The general impression of the electrical installation was poor.

- Domestic cable has been used which is unsuitable for marine electrical installations because it is made from solid wire rather than stranded wire.
- A domestic consumer unit was used to distribute power to the various circuits. It was very poorly wired, e.g. no earth bus bar was used.
- Many circuits appear to rely on the use of extension leads with four gang sockets.
- Polarity appeared to be reversed see below.

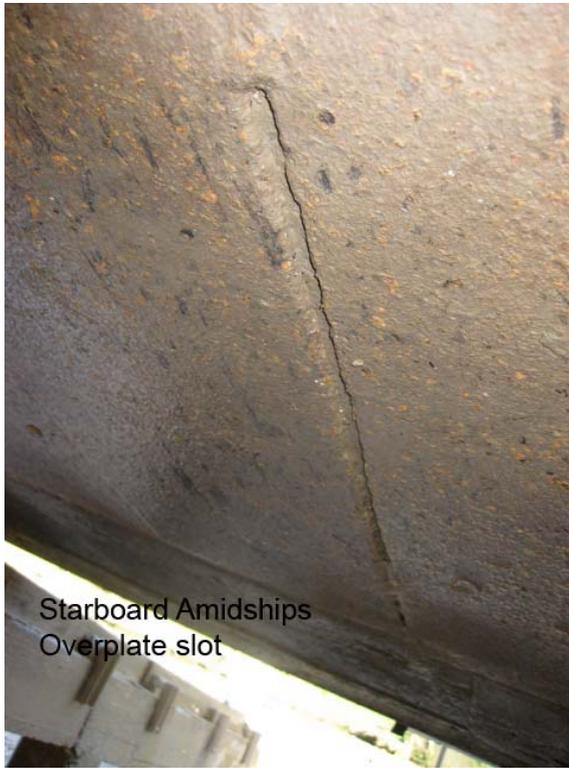
There were a number of locations where groves between plates that may promote crevice corrosion and are difficult to monitor for plate thickness. Examples are shown in Appendix B. These should be overplated.

Starboard Amidships  
Overplate slot

*Overplate groves and slots between plates.*

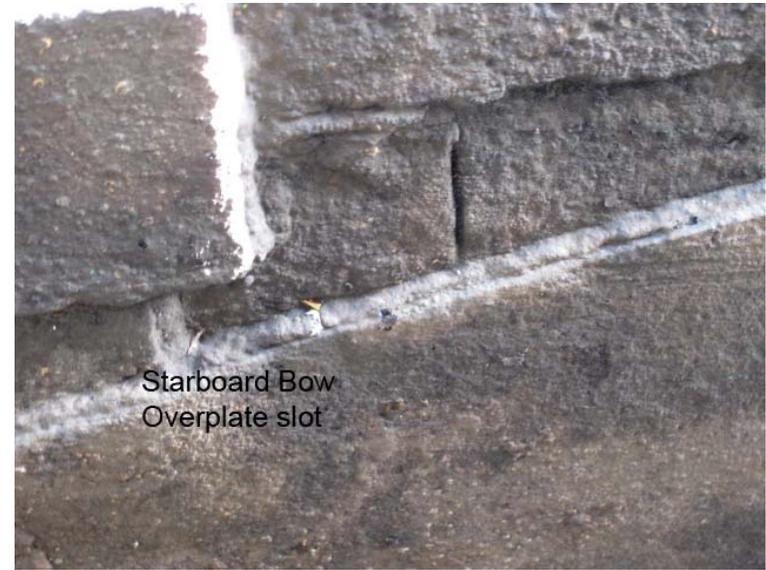
Starboard Bow  
Overplate slot
