Name of Vessel:

Hugh Ellacott

Yacht and Small Craft Surveyor

About the Survey and this Report

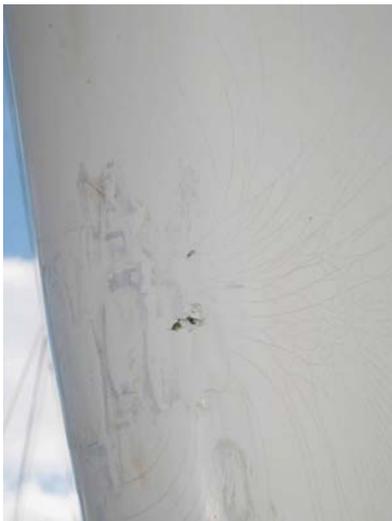
Impact damage was seen on the stem, which appears to be the effect of two separate collisions, see photo left. Crazing has occurred in a radius of approximately 250mm around the points of impact. Hammer sounding did not identify any delamination of the laminate within this radius apart from at the very point of impact. The laminate was spike tested at the point of impact and it was found to be solid. Moisture was high in the immediate vicinity of the point of impact (60-80 on both shallow and deep modes). In summary, it is considered that there is little loss of structural strength as a result of the damage to the stem and main consideration is cosmetic.

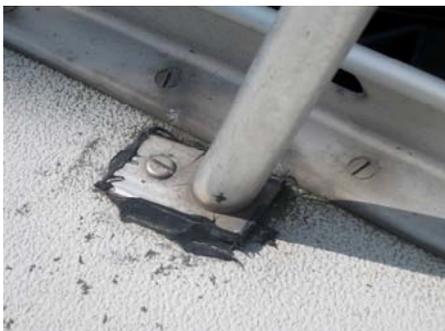
The stanchions are attached to the toerail; each was physically tested and found to be secure apart from those around the port and starboard boarding gates. The forward port gate stanchion was loose and the feet for the aft one did not lie fair to the deck. On the starboard side the foot for the forward gate stanchion has been refastened to the deck, though it still does not lie fair, see photo. The stanchion itself was more secure than the equivalent one on the port side.

*Advice**Fasten gate stanchions more securely.*

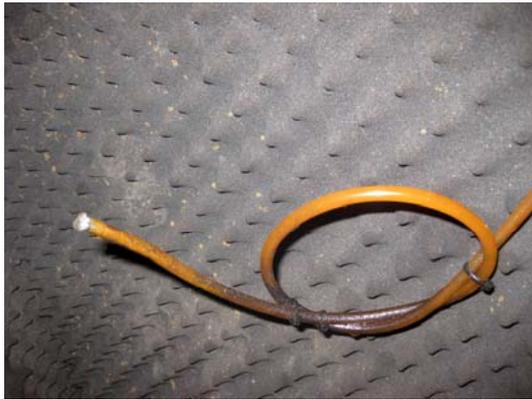
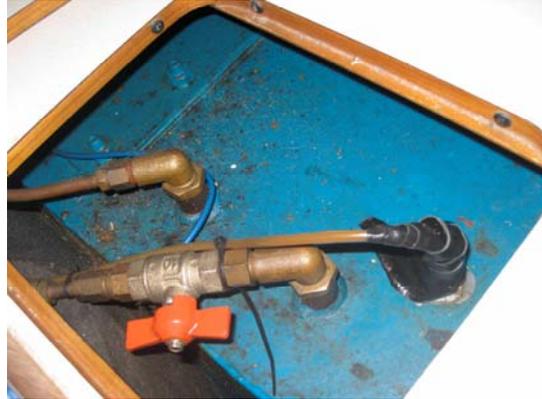
In addition to the engine delivery line there is a second line that supplies a diesel heater fitted in the engine compartment. The take-off for this fuel line is adjacent to the engine take-off, but consists of a plastic auto fuel pipe held to the top of the tank by electrical tape. It was unclear whether there is a proper fitting underneath the tape and I felt it best not to disturb the precarious hold the tape has to the top of the tank, see photo below. The diesel is then delivered to the heater via a series of unsupported plastic components. In addition, another plastic auto fuel pipe is "T"ed onto this line. (It ends in a valve downstream of which is another piece of plastic pipe filled with diesel blanked off with a self-tapping screw.) It was not leaking when viewed, see photo below. All the above are in the engine compartment and could exacerbate a fire in the compartment.

The fuel delivery system should be upgraded to meet best practice. All plastic and rubber hose should be replaced by supported copper pipe. Valves should be placed on all fuel lines leaving the tank in such a position that they can be shut in the event of a fire in the engine compartment. Redundant fuel lines should be removed.
