**Name of Vessel:**

**Hugh Ellacott**

**Yacht and Small Craft Surveyor**

## 1. About the Survey and this Report

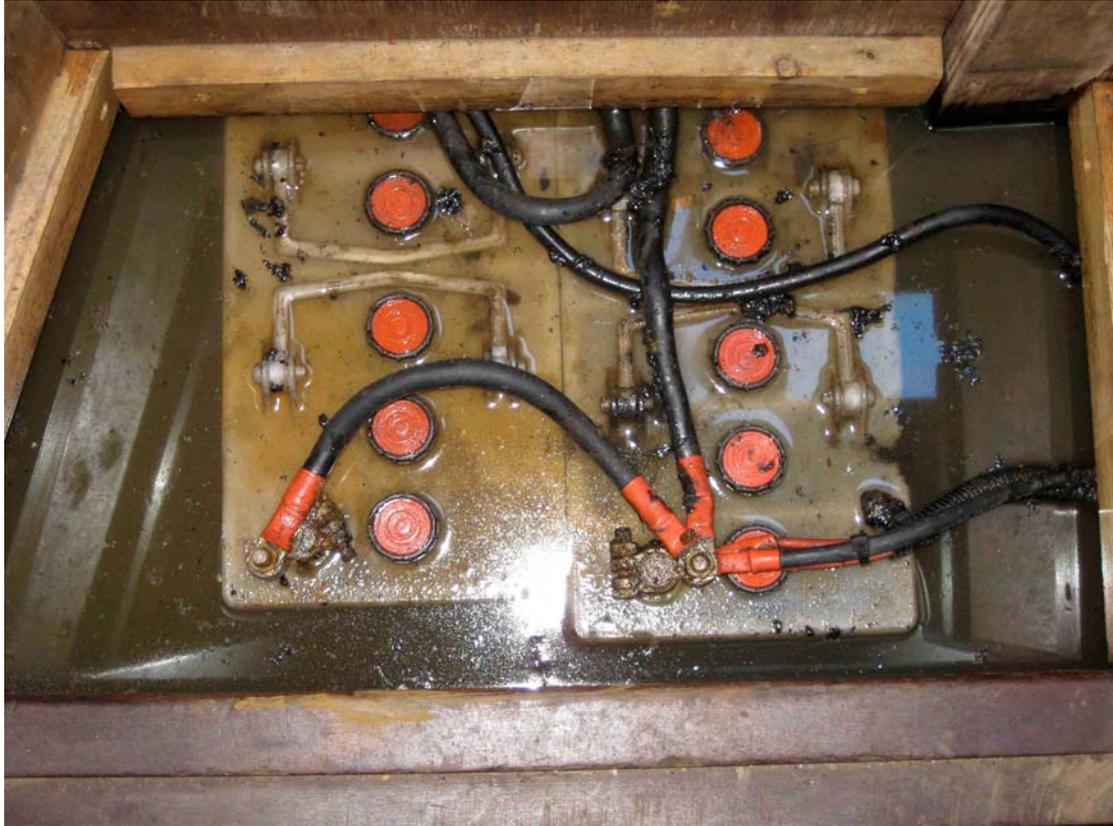
At the time of the survey, water in the battery compartment was level with the top of the batteries, which hampered the survey (see photo).

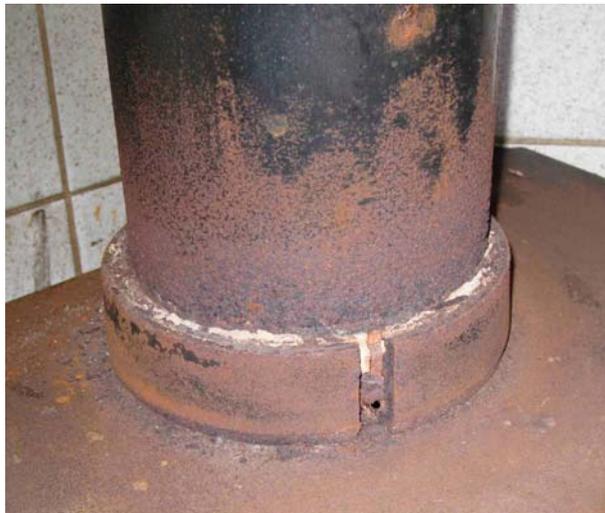
A Little Squirrel solid fuel stove, made by Morsø, was installed in the saloon. It was in a dangerous condition and should not be used until it has been serviced. The main fault was that the blanking plate in the rear panel of the stove had completely disintegrated and when lit the stove would fill the saloon with smoke. The seal between the top plate and the flue had also failed and would also emit smoke into the saloon (see photo).

The main door of the stove could only be closed by applying strong pressure to the door, which would not be possible, when the stove is hot. It was not possible ascertain why the door was difficult to close - it may be because of the seal, or there may be deformation to the front panel or door. The rear firebrick had broken in half.
