Pre Purchase Survey

**Name of Vessel:** [REDACTED]

[REDACTED]  
Widebeam Narrowboat

Length Overall	40ft
Beam	8ft 10ins
Built	1982
Builder	Not known
Fitted Out	Owner
Engine	BMC 1.5

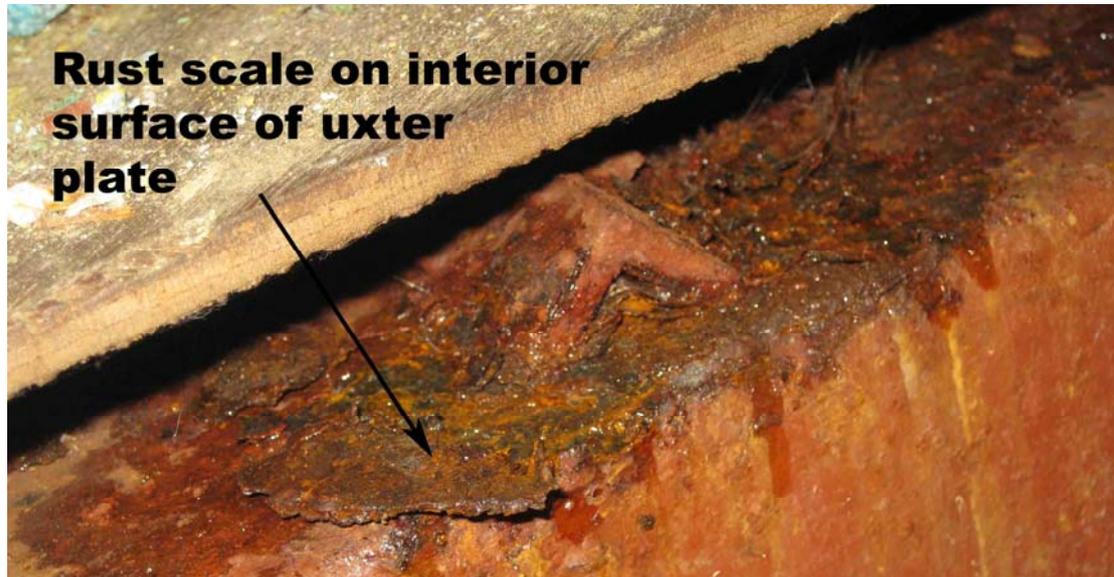
The side shell was seen in a locker, no coating was noted and surface rusting was present. In the engine compartment the steelwork was coated with red paint, probably red oxide primer. The uxtter plate was lined with ply but at the linings' edge scale and moisture was noted (see photo). The presence of scale and external ultrasonic

thickness measurements suggest corrosion is affecting the uexter plate and it would be prudent to remove the lining in order to treat the steel beneath to prevent further corrosion occurring.

*Remove lining from uexter plate to inspect for corrosion. Where present, prepare steelwork for painting by removing all scale, rust and loose paint, treated with rust inhibitor and coat with a primer and bilge paint.*

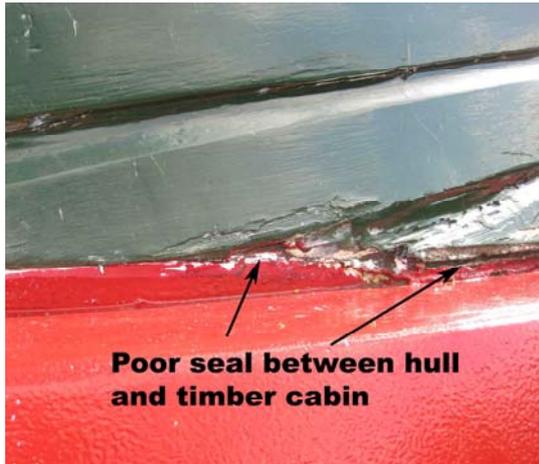
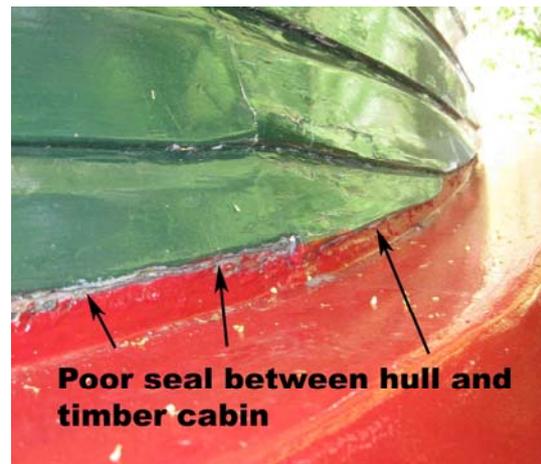
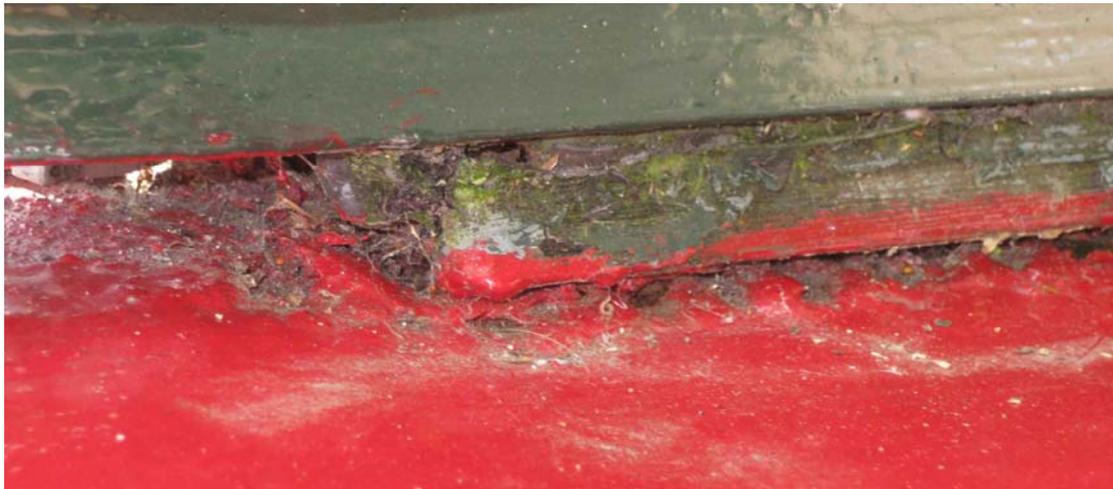
The cabin was constructed from timber; external skin was soft wood tongue and groove fastened parallel to the deck. The timber was finished in green gloss paint that was in good condition. The lower edge of the bottom edge was carefully examined for fungal rot, none found. However, in places the lower edge did not take paint well indicating the timber has weathered. Mastic had been used to seal the joint between the hull and the timber cabin. It had failed particularly on curved sections. Leaks were possible, though this cannot be established by visual examination (see photos below). No evidence of leaks was seen inside the cabin.

Maintaining the seal will require routine on-going maintenance using good quality materials.

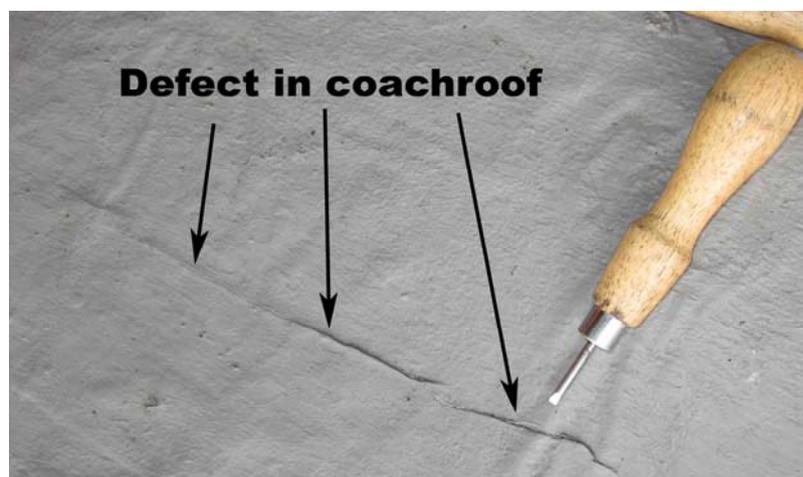
The coachroof was covered with a grey coating that had incorporated a fibre. The underlying weather protection was not identified. The roof was hammer sounded and only two small areas where the coating had delaminated were found. Visual inspection revealed some cracks in the covering/coating but it was not apparent whether these would result in leaks (see photo below). No evidence of leaks was seen inside the accommodation.

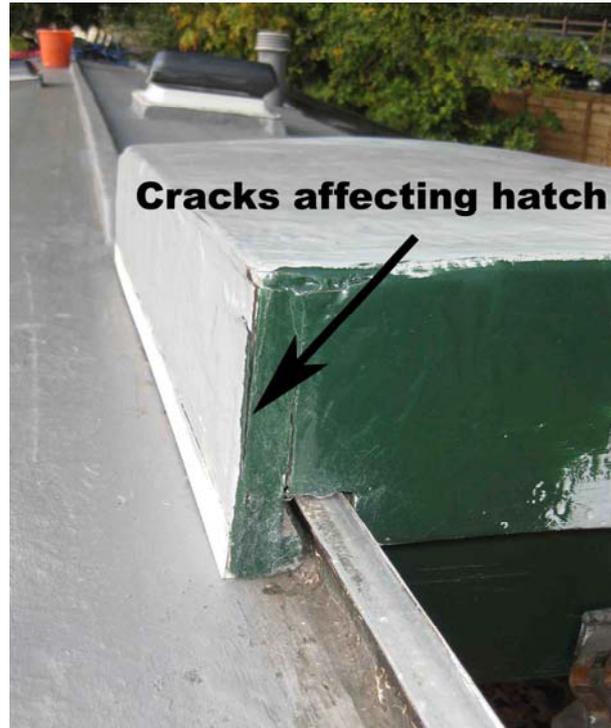
A hatch and double doors provided access from the aft deck. The hatch was of light timber construction and slid (not smoothly) on runners. It was in poor to moderate condition, see photo below.

The hatch and doors were secured by an external padlock and hasp and internal bolts. The internal bolts did not adequately secure the hatch. If padlocked externally emergency exit is prevented; the Boat Safety Scheme (BSS) requires two means of exit from a vessel.

*Provide an internal means of securing the aft hatch and remove external padlock and hasp. Undertake immediately.*

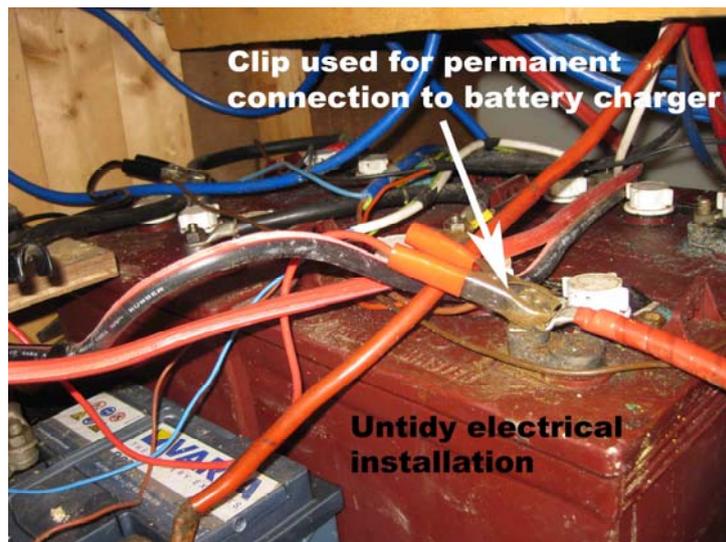
Wiring was untidy in the vicinity of the battery banks indicating the poor quality installation. A battery charger was permanently connected to the battery bank. It would be prudent to investigate whether the charge is designed to be permanently connected to a battery bank. It was noted that clips were used to connect the charger to the battery bank – permanent connectors should be used.

*Commission a marine electrician to examine electrical systems.*

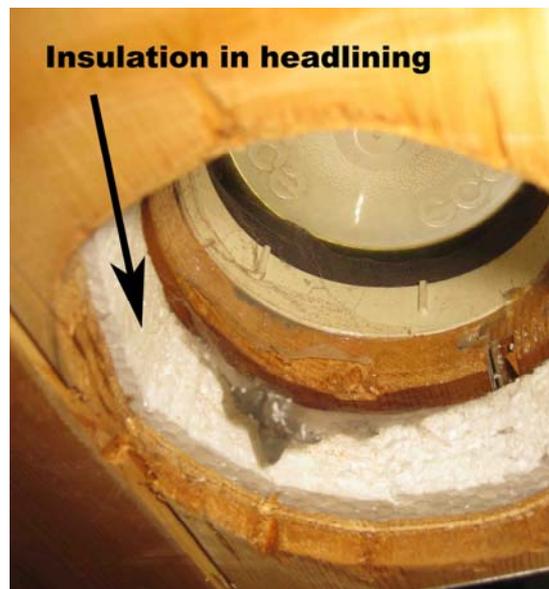
A solid fuel stove was located in the saloon. It was secure, the hearth provided good insulation and flued through the coachroof. A fire brick was noted as missing from the back of the fire box. It would be prudent to replace the missing brick as it will prolong the life of the stove. Polystyrene insulation was seen in the headlining and the cabin sides (port side forward locker).

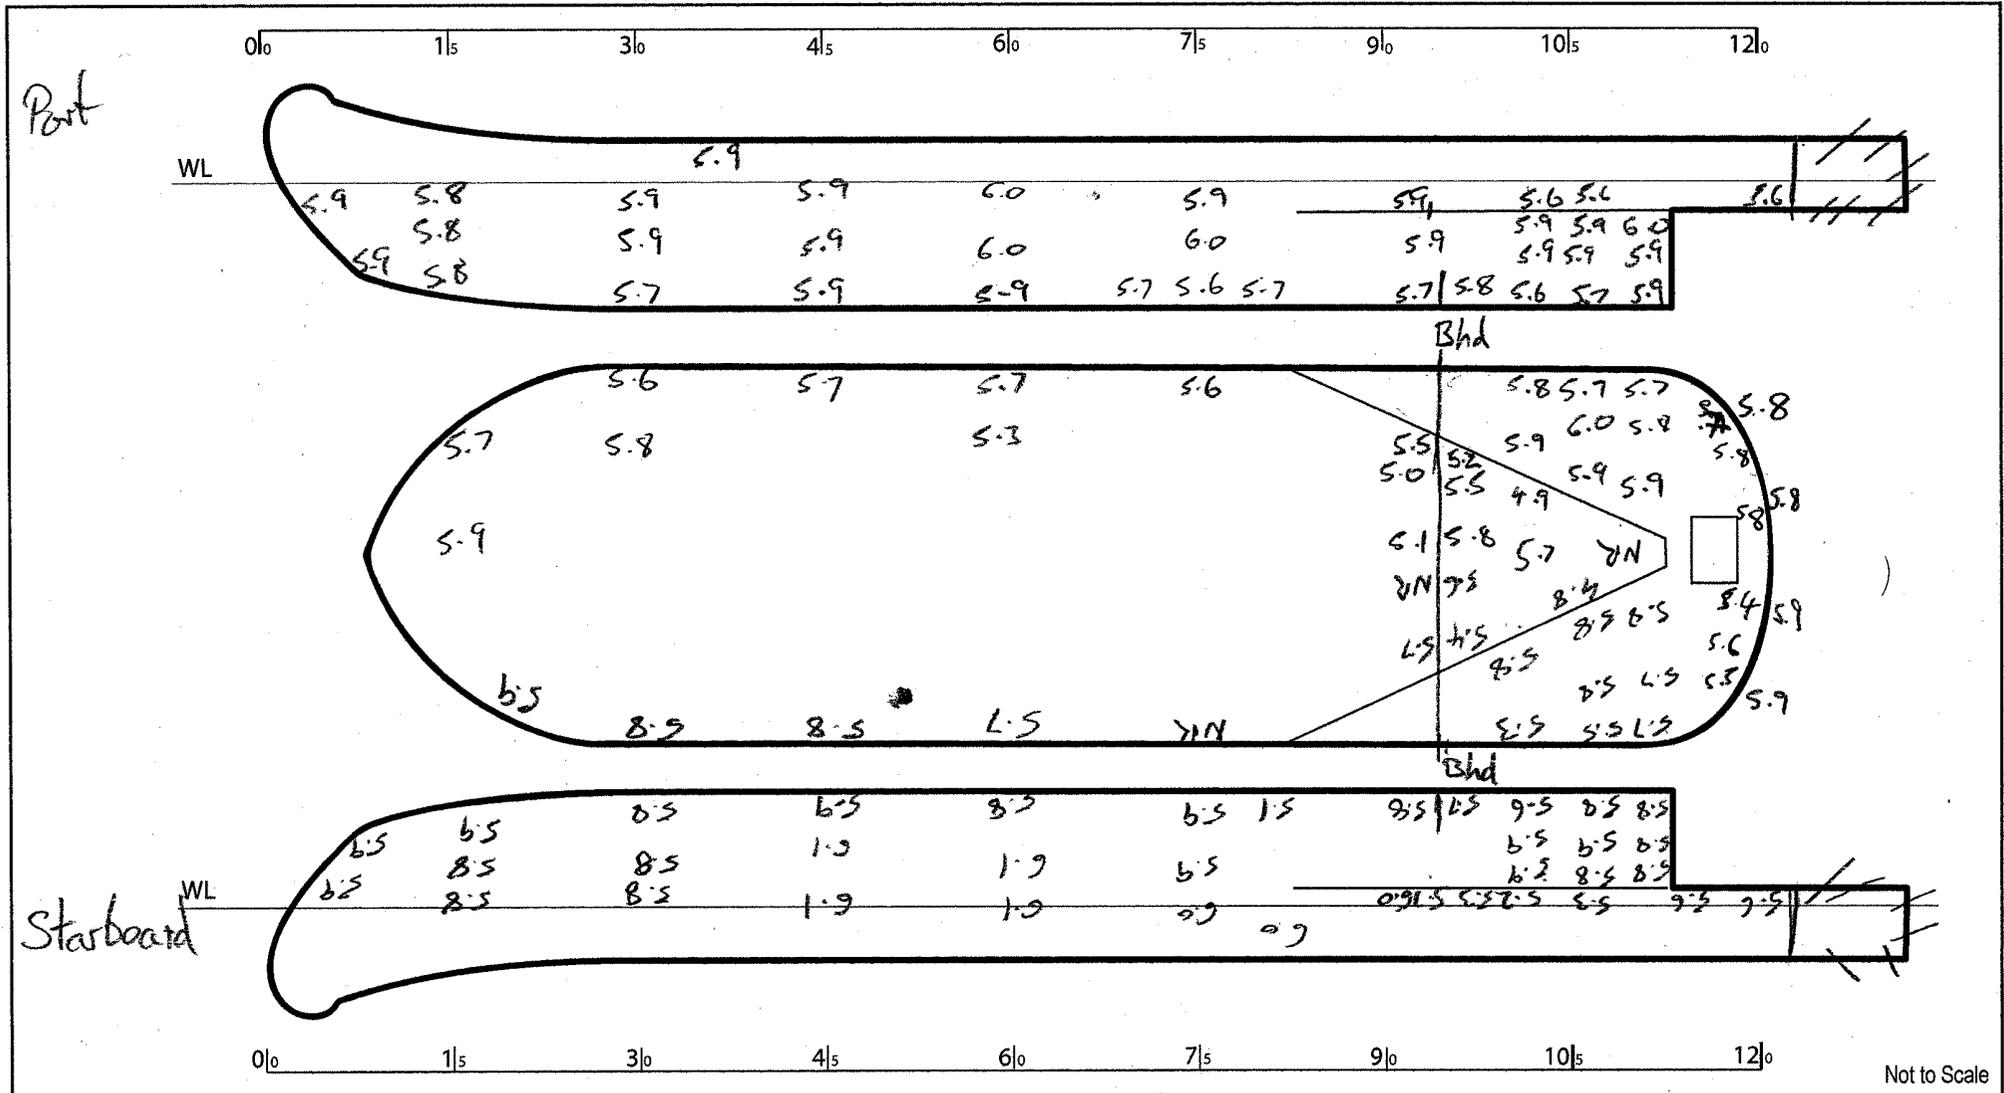
## **APPENDIX B: Sketch of Ultrasonic Thickness Measurements**

Ultrasonic thickness measurements were taken as described in Appendix A. Readings were taken every 1.5m on both sides of the hull. Sketch 1 in Appendix B shows the results of gauging the thickness of the hull plating. Measurements were taken at the waterline, the foot and midway between the two points where appropriate. Measurements on the bottom plate were taken approximately 50mm from the chine, where most severe external abrasion and internal corrosion is likely to occur, and along the centre line where access was not prevented by the trolley. At the stern additional readings were taken on the uxtter plate and swim plates.

The nominal thickness of the plates (including bottom, uxtter, swim and side plates) when constructed is assumed to be 6.0mm

The ultrasonic thickness measurements revealed that there has been only limited corrosion affecting the hull. Internal corrosion was noted to the side shell by way of the toilet compartment where the lowest thickness measured was 5.1mm. Diminution was also noted to the uxtter plate, see Section 4. The lowest measurement taken was 4.9mm on the bottom plate by way of the engine compartment. No remedial work was required.
