**Name of Vessel:**

**Hugh Ellacott**

**Yacht and Small Craft Surveyor**

## 1. About the Survey and this Report

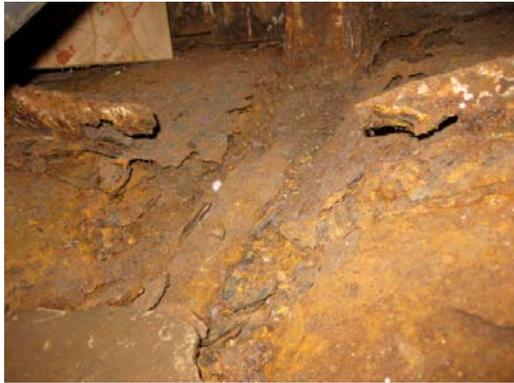
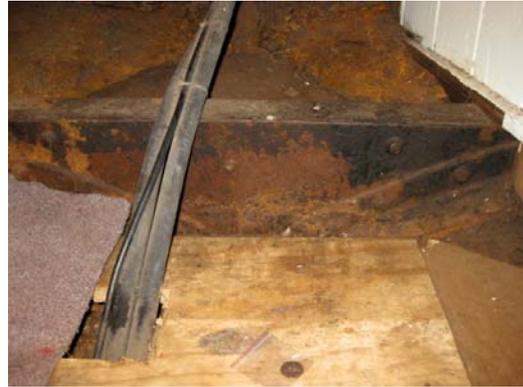
It was only possible to examine structural frames in a very few locations. Above the level of the lower deck sole (floor) the interior steelwork has been spray-foamed. On the starboard bow frames were measured at approximately 18 inch centres, but could not be examined because of the foam. In the back cabin it was possible to see two frames, both have suffered from extensive corrosion, but only the forward one has been repaired. The shell at this point was also perforated and it was assumed that this part of the counter stern, which is above the waterline, has been overplated.
